Field Performance Of Soil Pressure Cells (General Transducer Company)

Interim Report

## FIELD PERFORMANCE EVALUATION OF SOIL PRESSURE CELLS

**NO. M & R 632954-1**

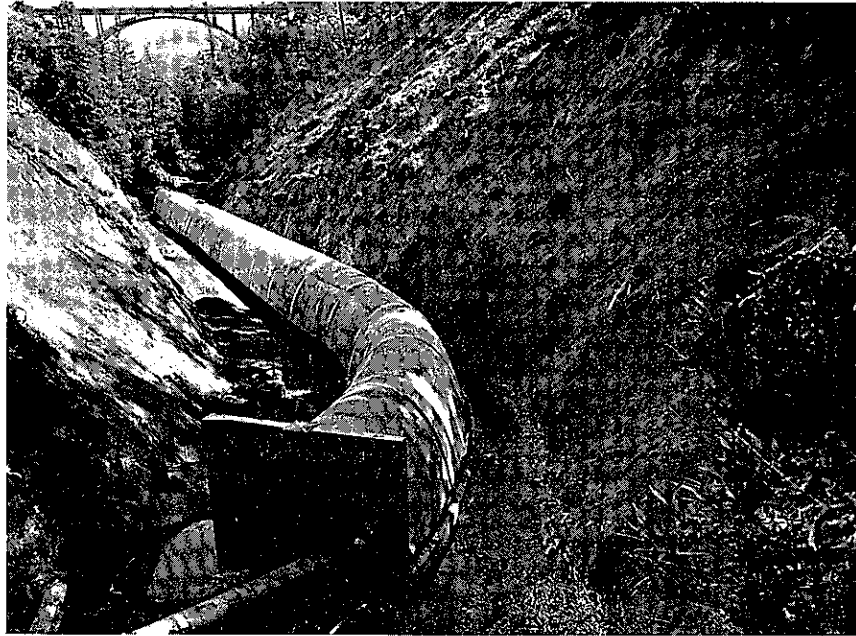
Figure 7. Cedar Creek Culvert - looking northeast from downstream end.

sand of low to moderate plasticity. The view in Figure 7 is from the downstream end of the culvert prior to placing the backfill and embankment. The bridge shown in the background carries traffic on the existing highway and is approximately the same elevation as the top of embankment over the culvert. (Note the steep side slopes of 1:1 or steeper at the bottom of this V-shaped canyon.)

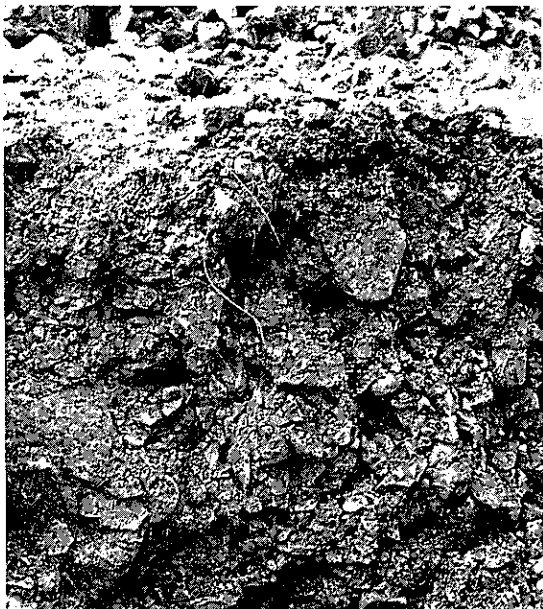
Figure 27.  
Instrumentation trench side  
wall. Note extremely rocky  
embankment material.
